Author: Toomas Kaljas CEO / Chief Engineer  
Rak Tek Solutions Oy

## Preliminary analysis of Maxima chopping centre in Riga on 21.11.2013

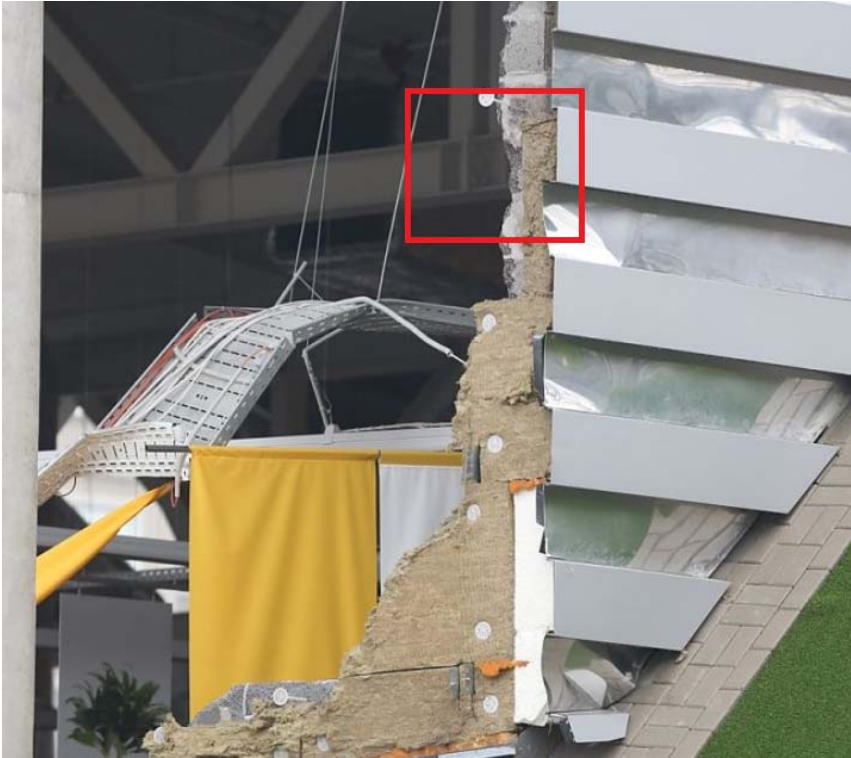
Based on photographic evidence presented in media, it is obvious that the primary cause for such collapse is the steel truss bolted tension connection. Steel truss, is made out of two pieces, which are assembled on site using bolted connections. The bottom chord tension connection is at least **two** times under-designed. The brittle connection is shown in figures **1** and **2**. The connection load carrying capacity can be manually calculated using yield-line method or analysed using modern FEM tools as shown in figure **7**.

Here the bolts are experiencing prying forces.

**Figure 1.** Truss bottom chord is connected with end plates and bolts which are in between steel beam flanges. The quantity and sizes of bolts are not sufficient for massive steel beam section. Bolts should also be placed outside of flanges (see figure 5 for example)

4. At least eight additional bolts symmetrical to I section massive flanges would have been needed.
5. End plate thickness and dimensions should have been decided based on elaborate yield line method analysis, including all effects of prying force etc.

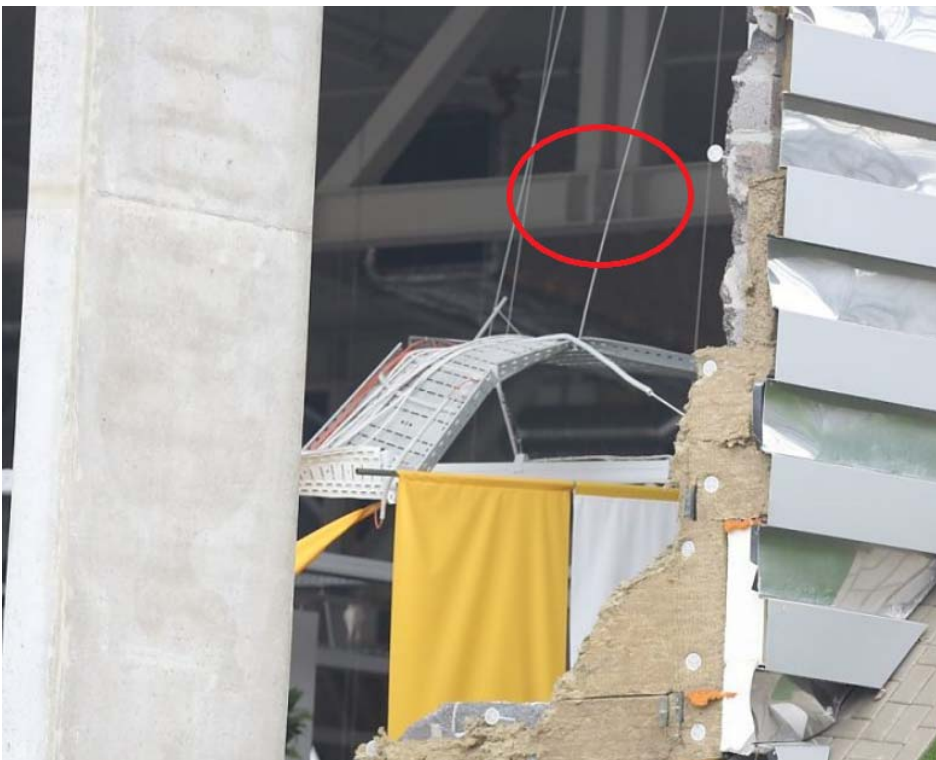
**Figure 2.** Same connection from different angle.

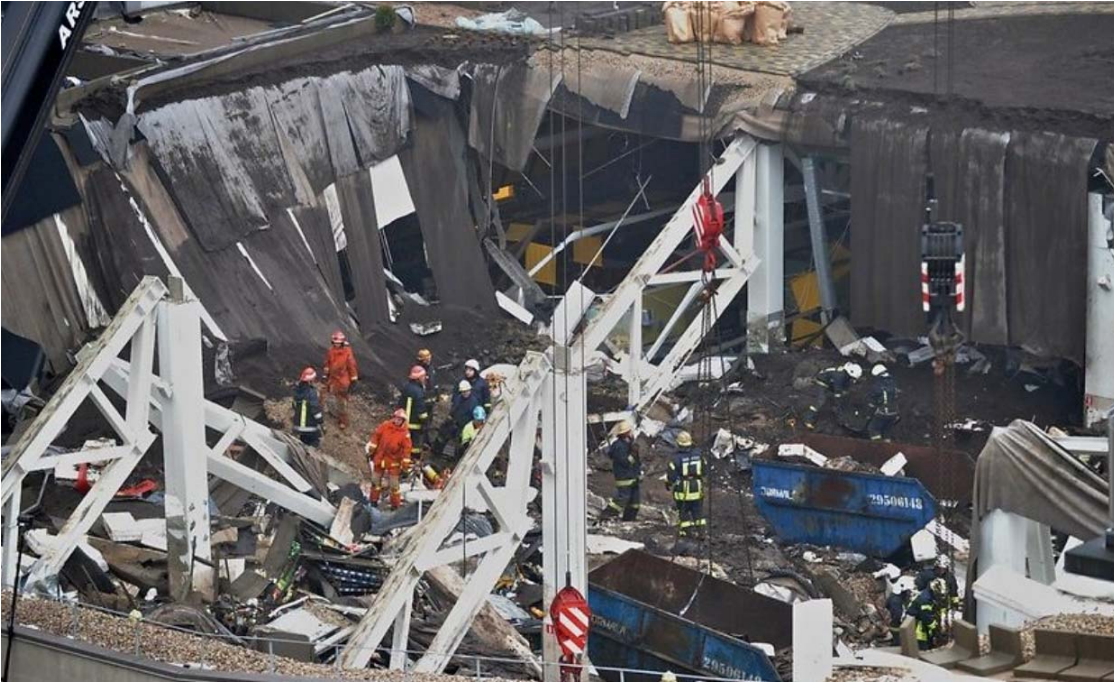
**Figure 3.** Steel trusses (**white**) have broken into two pieces and are buried under pile of rubble. The connection in figure 1 and 2 has caused brittle and sudden collapse without any warning. Several other design mistakes are also obvious but of less importance in this case.

6. The frame in photos is short. This truss could have been made into single piece, without that dangerous and faulty connection.
7. The failure of this connection can still be tested on site, after the evacuation and rescue work has been completed. This real life test would end all discussions, since high-speed camera can record the process of collapse from many angles and with sufficient high quality. This testing shall be carried out with utmost care and preparation.

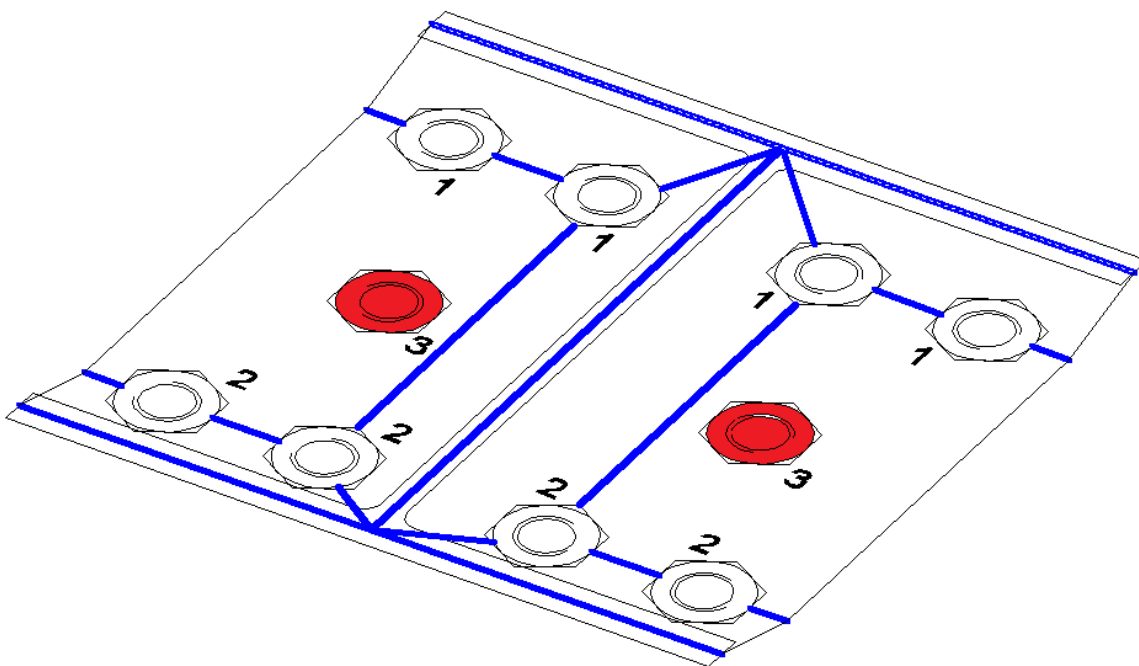
It can be seen from yield line analysis (figure **4**) and more advanced FEM-analysis, that bolt forces are not evenly distributed. Center bolt is completely useless in load carrying.

The uneven distribution of bolt loads is caused by **well-known prying force phenomena**. **EN 1993-1-8** states: “Where fasteners are required to carry an applied tensile force, they should be designed to resist the additional force due to prying action, where this can occur.”

**Figure 4.** Drawing of end plate in failed connection. **Blue lines** represent yield lines in end plate. Due to yielding pattern of end plate, bolts near the web of I-beam experience much higher forces. **Nr 3 row center** bolts are **completely useless**, visible on **figure 4 as red**.

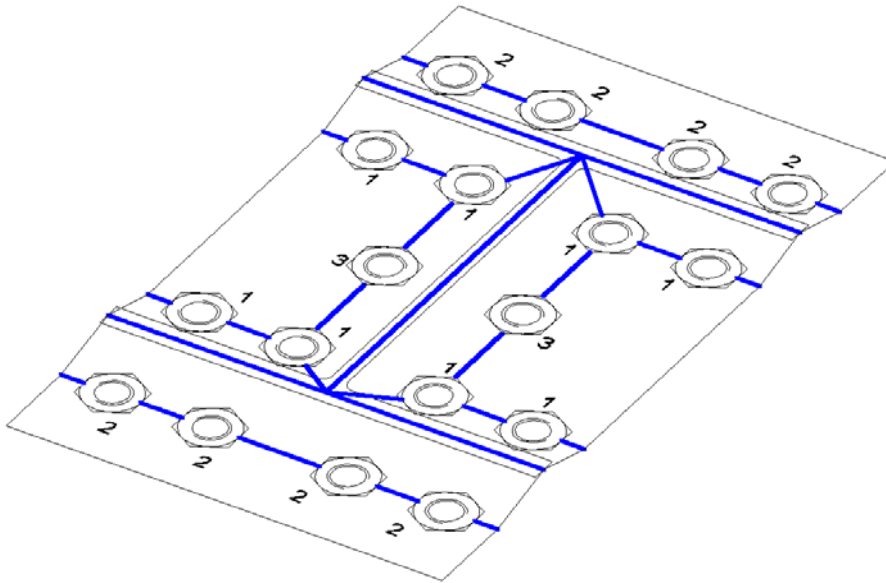
**Figure 5.** Example of properly arranged bolt placement. This connection shows the need of **eight additional bolts** outside the flanges (in rows nr 2). All bolts are useful in this configuration. **Blue lines** are representing plate yield lines.

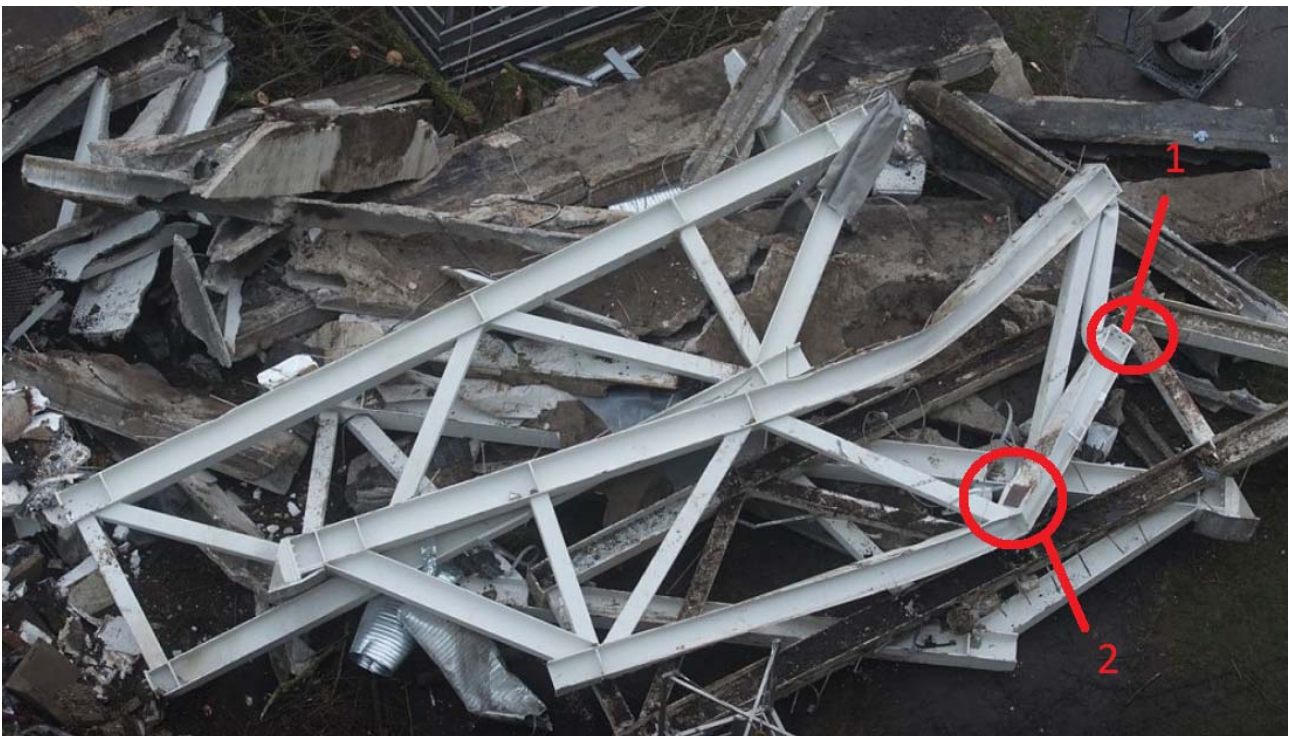
**Figure 6.** Tension connection (**1**) has failed from bolts just as theory would predict. Connection (**2**) has failed during the collapse, since this diagonal is in compression and does not fail or fracture in normal compression loading conditions. Only tension bars and connections rupture.

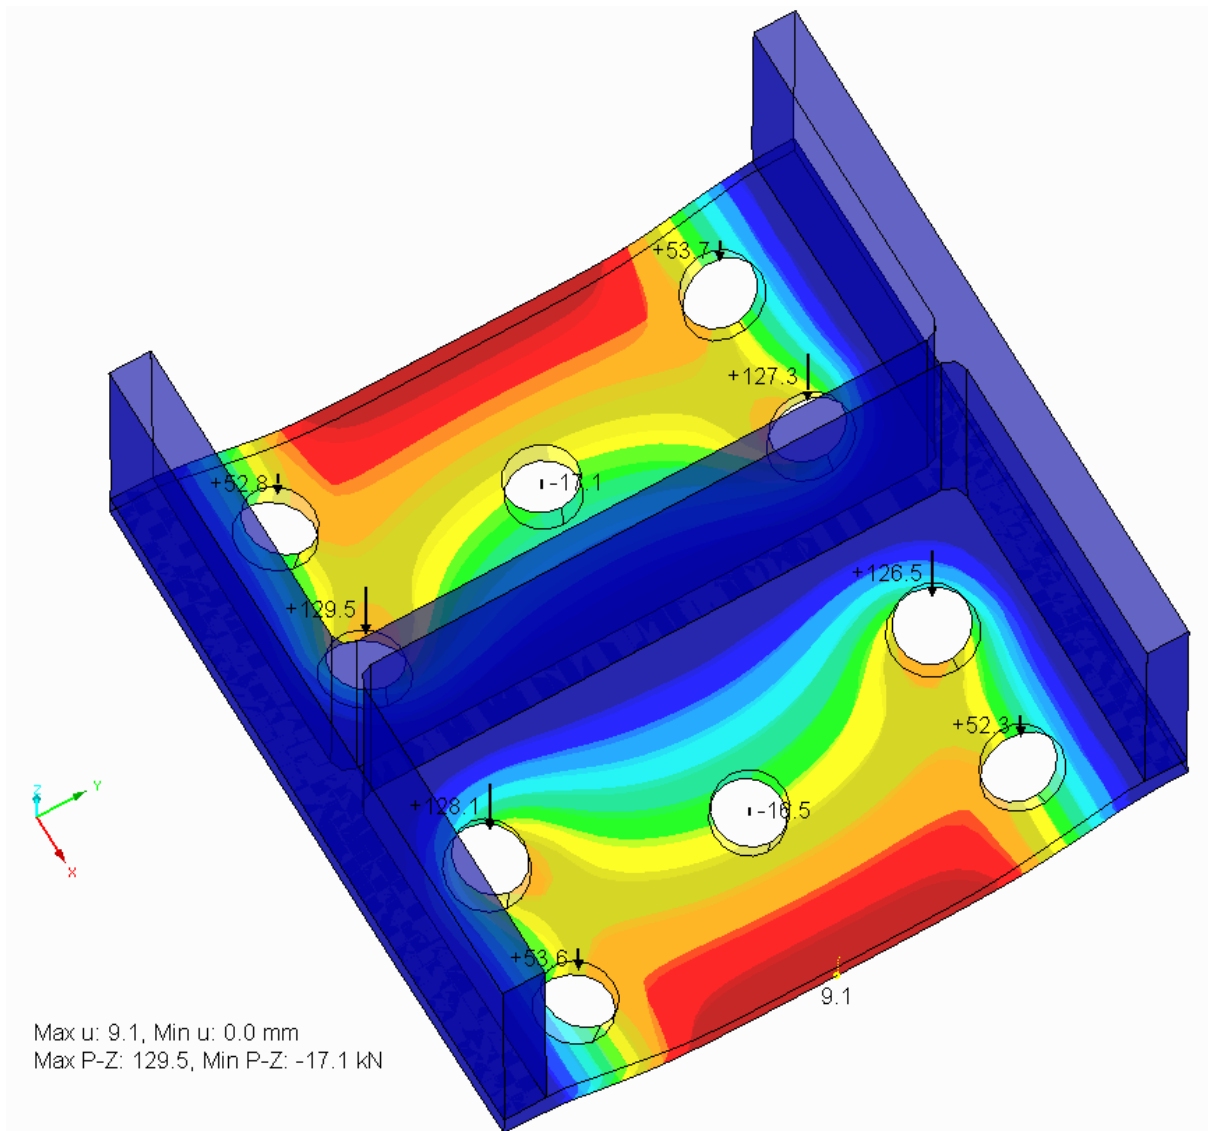
**Figure 7.** Example **FEM** model of the failed connection in Maxima chopping center. Center row **3** bolts are in compression (negative loading in bolts) (totally useless). Bolt forces are not evenly distributed. Maximum loaded bolts will rupture first and then all other will follow. Rupture can cause sound similar to “explosions”.
