Author: Toomas Kaljas CEO / Chief Engineer  
Rak Tek Solutions Oy

## Preliminary analysis of Maxima chopping centre in Riga on 21.11.2013

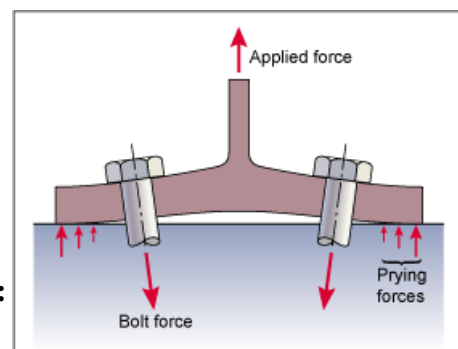
Based on photographic evidence presented in media, it is obvious that the primary cause for such collapse is the steel truss bolted tension connection. Steel truss, is made out of two pieces, which are assembled on site using bolted connections. The bottom chord tension connection is at least **two** times under-designed. The brittle connection is shown in figures **1** and **2**. The connection load carrying capacity can be manually calculated using yield-line method or analysed using modern FEM tools as shown in figure **7**.

The uneven distribution of bolt loads is caused by **well-known prying force phenomena**. **EN 1993-1-8** states: “Where fasteners are required to carry an applied tensile force, they should be designed to resist the additional force due to prying action, where this can occur.”

Here the bolts are experiencing prying forces.

**Figure 1.** Truss bottom chord is connected with end plates and bolts which are in between steel beam flanges. The quantity and sizes of bolts are not sufficient for massive steel beam section. Bolts should also be placed outside of flanges (see figure 5 for example)
